Griffin Home Inspection Inc.

1234 School House Road
Yourtown, US 12345

General Information

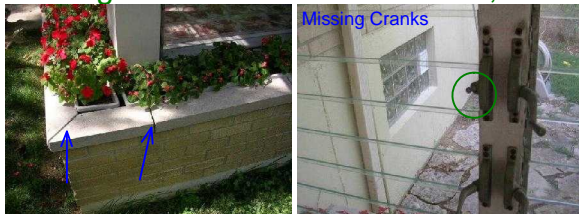
5. Marginal **Patio/Enclosure:** Ceramic tile, Brick, Aluminum windows - Loose limestone wall caps, Missing screens and some cranks, Lubricate as required

Walks: Cracks noted, Heaving at walk at rear 3 season storm door	\$ 50	\$ 150
Porch: Loose handrail	\$ 5	\$ 25
Patio/Enclosure: Missing screens and some cranks	\$ 15	\$ 75

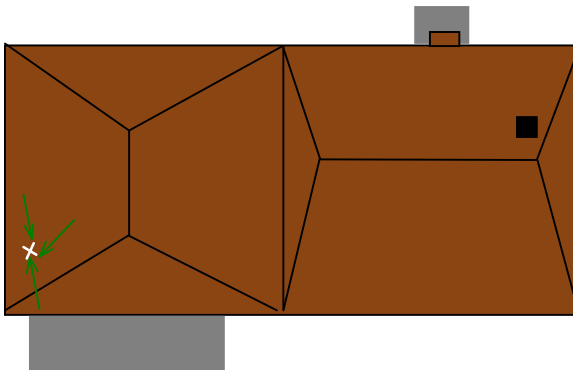
Material: Fiberglass shingle - Moss growth noted

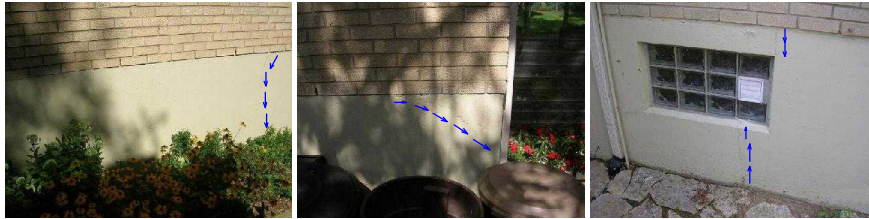
Foundation: Poured concrete - Common cracks noted near windows, Spalled foundation corners noted

Differential Movement: Differential settlement present - Cracks will require monitoring

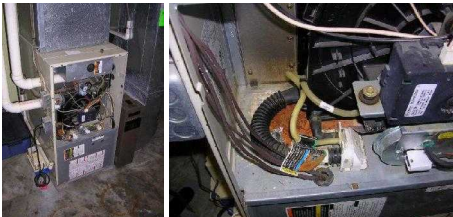
1. Defective **Heating System Operation:** Note: - Non-functional at time of inspection, A qualified HVAC technician is recommended to review and correct as required, Condensation leaking stains noted in cabinet
2. **Manufacturer:** Carrier

Basement Heating System Heating System Operation: Non-functional at time of inspection, A qualified HVAC technician is recommended to review and correct as required.	\$ 75	\$ 200
---	-------	--------

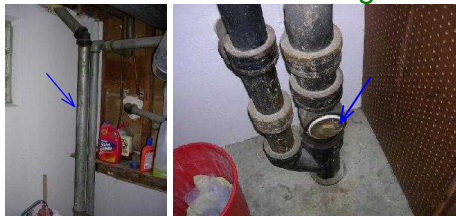
- 3. Acceptable **Water Lines:** Copper
- 4. Marginal **Drain Pipes:** Cast iron, Galvanized - Slow draining noted at Tub. A licensed plumber is recommended to evaluate and estimate corrections, Galvanized drainpipe present- Galvanized piping corrodes from inside causing decreased flow rates and will eventually require updating. Noted new clean out cap which may indicate access was needed to clear drain clog

Drain Pipes: Slow draining noted at Tub. A licensed plumber is recommended to evaluate and estimate corrections.	\$ 10	\$ 80
---	-------	-------

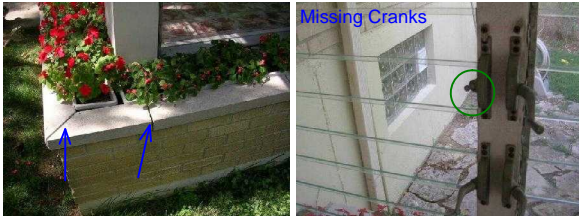
3. Patio/Enclosure: Ceramic tile, Brick, Aluminum windows - Loose limestone wall caps, Missing screens and some cranks, Lubricate as required

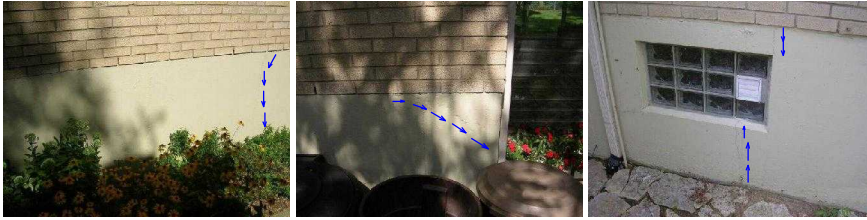
8. **Foundation:** Poured concrete - Common cracks noted near windows, Spalled foundation corners noted

9. **Differential Movement:** Differential settlement present - Cracks will require monitoring

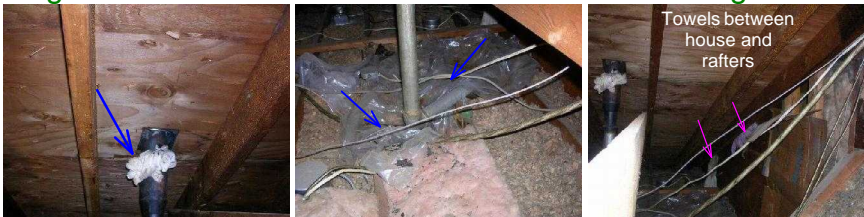
12. **Partial house-Lower Attic Moisture Penetration:** Previous water penetration noted - Previous water penetration noted at plumbing stack penetration with plastic in attic to catch water and towels wedged between house and rafter- no current leaking detected - Monitor

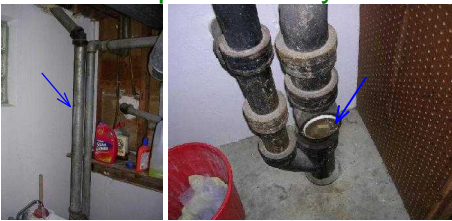
17. **Drain Pipes:** Cast iron, Galvanized - Slow draining noted at Tub. A licensed plumber is recommended to evaluate and estimate corrections, Galvanized drainpipe present- Galvanized piping corrodes from inside causing decreased flow rates and will eventually require updating. Noted new clean out cap which may indicate access was needed to clear drain clog

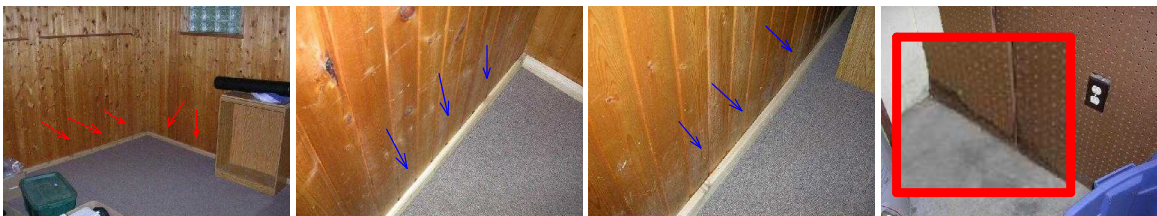
6. **Main Basement Moisture Evidence:** Note - Suspected mold present along perimeter finished walls at left and rear elevations. Further investigation behind finishes may uncover hidden problems not visible in this visual inspection. Mold conditions can cause acute and chronic health concerns and should be remediated. Corrections may include remediation protocols provided by an environmental hygienist for the suspected mold conditions and qualified remediation contractors to make required corrections.

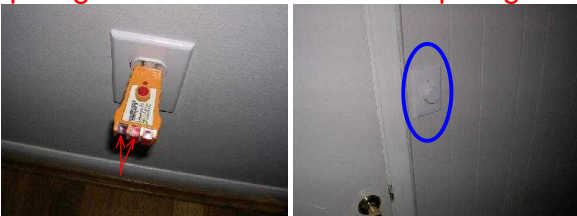
14. **Lower Level Living Space Electrical:** 110 VAC - **Faulty operation at light dimmer switch-repair, Open ground exists at several 3prong outlet receptacles**

Lower Level Living Space Electrical: Faulty operation at light dimmer switch-repair	\$ 15	\$ 75
--	-------	-------
