Griffin Home Inspection Inc.

1234 School House Road
Yourtown, US 12345

General Information

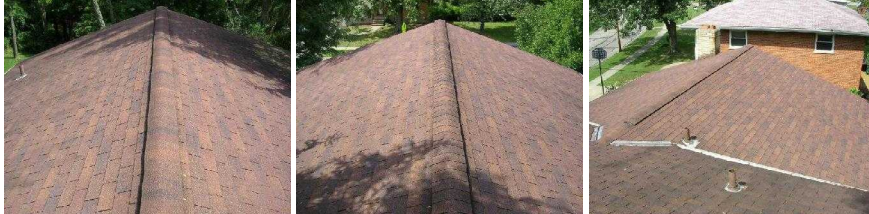
Main Roof Surface

Material: Fiberglass shingle - Moss growth noted

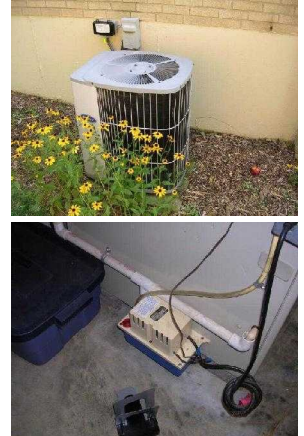
1. Defective **Heating System Operation:** Note: - Non-functional at time of inspection, A qualified HVAC technician is recommended to review and correct as required, Condensation leaking stains noted in cabinet
2. **Manufacturer:** Carrier

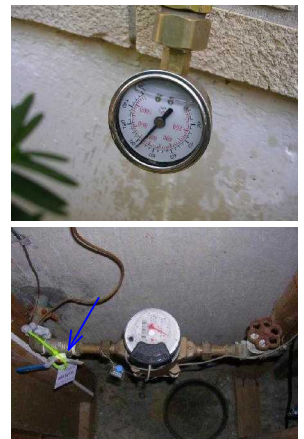
- 3. Acceptable **Water Lines:** Copper
- 4. Marginal **Drain Pipes:** Cast iron, Galvanized - Slow draining noted at Tub. A licensed plumber is recommended to evaluate and estimate corrections, Galvanized drainpipe present- Galvanized piping corrodes from inside causing decreased flow rates and will eventually require updating. Noted new clean out cap which may indicate access was needed to clear drain clog
